Home Inspection Report

555 Angus Ave., San Bruno, CA

Inspection Date:
Thursday, October 25, 2012

Report Number:
20121025-01

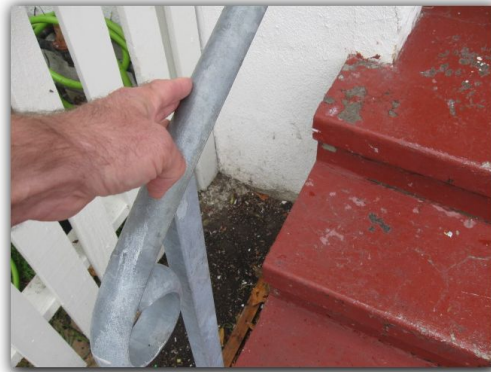
Handrails at stairs to front porch are not sufficiently secured. Could cause injury to those expecting handrail not to move. It is recommended that this finding and all associated components be reviewed and corrected as needed by a qualified, licensed contractor.

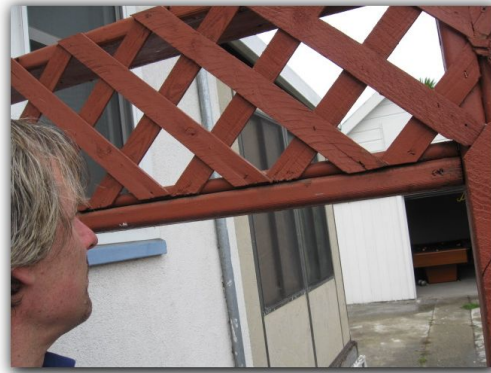
Wood framing above right rear gate creates a head-hitting hazard. May not be noticed by new residents, guests, or others, especially at night and cause injury. Caution is advised, and it is recommended that this finding and all associated components be reviewed, and corrected as needed, by a qualified, licensed contractor.

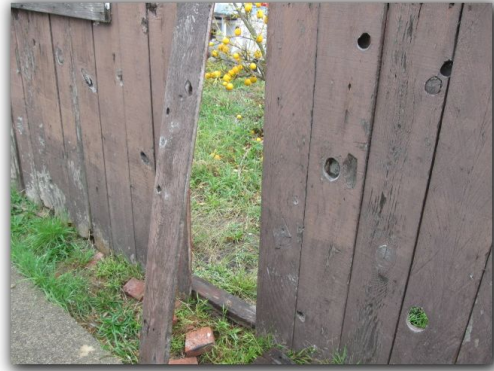
Fence slats at a number of locations are separated/missing and have deterioration. Recommend that this finding, all association components, and remaining fencing be reviewed, and corrected as needed, by an appropriate, qualified, contractor. Although fencing was not inspected per the California Real Estate Inspection Association Standards of Practice for home inspectors, this condition was noticed and reported as a courtesy. If inspection of remaining fencing is desired, contact an appropriate contractor.

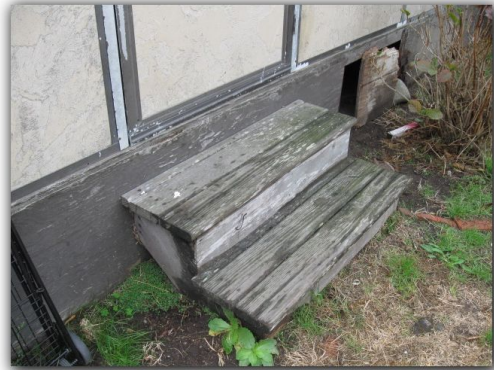
Stairs on rear side of building do not have a handrail. Although a handrail may not have been required at the time of construction, upgrading by having a handrail installed by a qualified licensed contractor can be expected to reduce the risk of injury from falling and will meet current construction safety practices for this number of stairs.

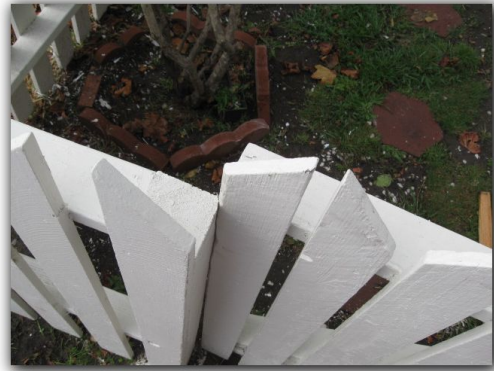
Gates at front side of building drag against posts. Recommend that this finding and remaining fencing be reviewed, and corrected as needed, by an appropriate qualified contractor. Although fencing was not inspected per the California Real Estate Inspection Association Standards of Practice for home inspectors, this condition was noticed and reported as a courtesy. If inspection of remaining fencing is desired, contact an appropriate contractor.

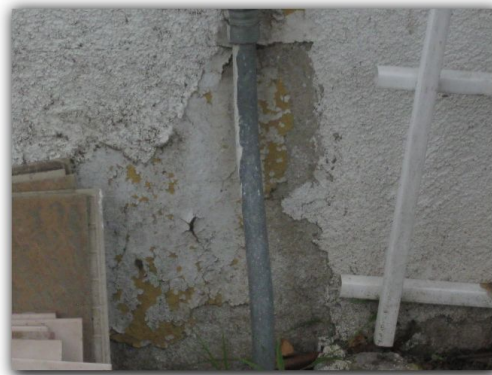
Stucco siding near bottom of left front corner of building is damaged. Recommend that this finding be reviewed, and corrected as needed, by a qualified, state licensed plastering contractor.

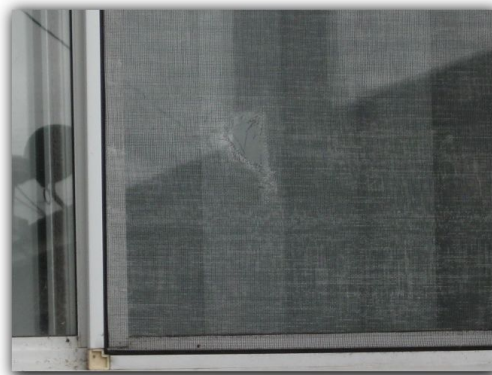
Screen on right window is holed. May allow pest/insect intrusion. Recommend repair or replacement by a qualified contractor.

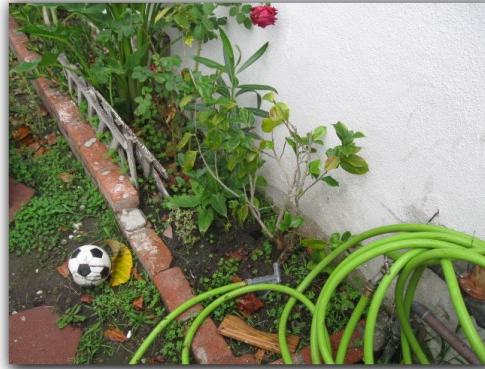
Planter on front side of building has soil in contact with stucco. Planter can retain moisture in soil and possibly expose stucco to excessive moisture, which may cause deterioration or microbial growth in siding or within wall. Inspection within walls is beyond the scope of a home inspection. Presence or condition of any barrier between soil and siding was not readily visible and should be determined/confirmed. Recommend that this finding and all associated/affected components be reviewed, and corrected if needed, by a qualified, state licensed General contractor or plastering contractor.

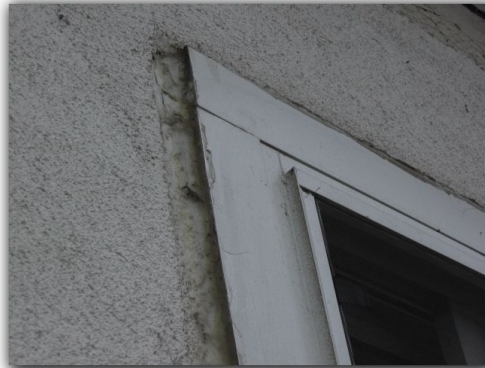
Cap flashing (flat metal to help prevent moisture intrusion between top of window and wall) on a number of windows has not been installed, increasing risk of moisture intrusion, which may cause deterioration of building materials within wall and promote microbial growth. Caulk is a temporary solution and is also less effective when windows are not flush with siding like these. Recommend that this finding and all associated components be reviewed, and corrected as needed, by an appropriate, qualified, state licensed contractor.

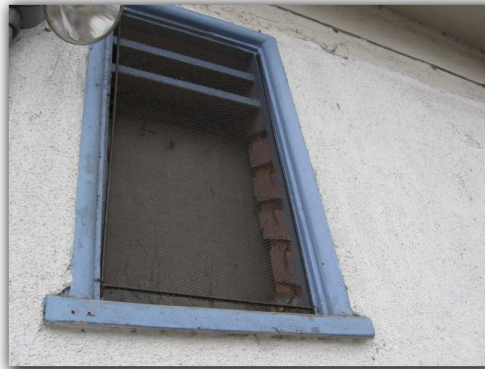
Opening on right wall near kitchen may allow moisture intrusion, which may cause deterioration of building materials within wall and promote microbial growth. Recommend that this finding and all associated components/areas be reviewed, and corrected as needed, by a qualified, state licensed General contractor or other appropriate, qualified contractor.

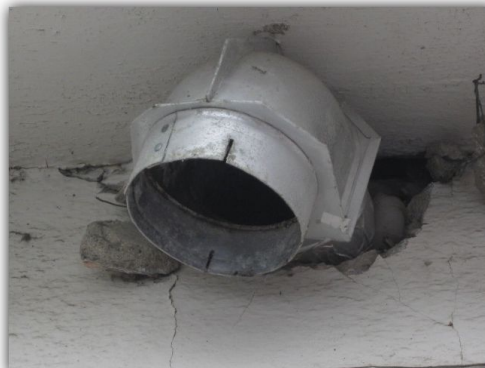
Dryer vent elbow has been installed under right eave as a termination cap apparently for bathroom exhaust fan vent. Recommend that this finding and all associated components/areas be reviewed, and corrected as needed, by an appropriate, qualified, contractor.

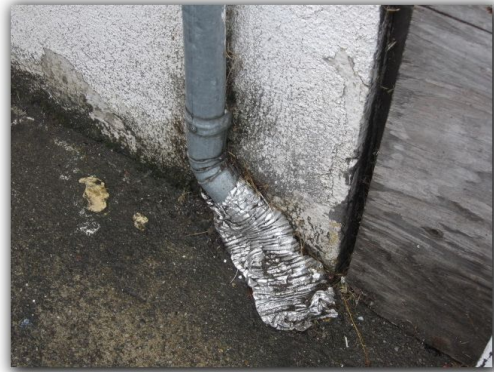
Gutter downspouts at a number of locations terminate, and deposit drainage, adjacent to the building. Although this may have been common during the era of construction, this condition may result in excessive moisture infiltration into siding, foundation, or under floor crawl space under certain circumstances. If downspout drainage volume is sufficient, drainage on grounds is insufficient, or soil is sufficiently expansive, excessive moisture exposure may cause deterioration, damage, microbial growth, unusual building movement, or encourage pest infestation. Also, some downspouts are draining water onto siding, increasing risk of siding deterioration, microbial growth, and moisture intrusion. Right rear downspout extension is crushed, restricting drainage and promoting clogging. Any pavement under downspouts that slope away from house may provide sufficient drainage. Recommend a drainage upgrade to divert gutter downspout drainage away from siding and building with gutter elbows and extensions that extend at least five feet away from building. Recommend that this finding be reviewed, and corrected as needed, by a qualified gutter contractor.

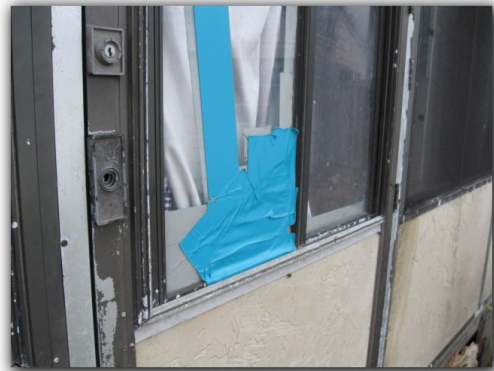
Rear room addition has a number of material defects, such as taped windows, wood deterioration, soil to wood contact, and unpainted wood. These types of additions are prone to leaking. Numerous personal items in room prevented view/inspection of a number of surfaces/areas. Undiscovered defects may exist. Recommend removal of personal items and having the interior and remaining structure reviewed, and corrected as needed, by a qualified, state licensed General contractor.

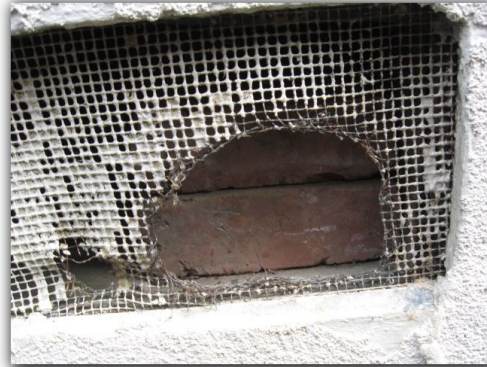
Crawl space vent on left rear corner of building is blocked due to holed screen, possibly reducing designed crawl space ventilation, which can increase moisture retention in crawl space and possibly cause deterioration and microbial growth. Recommend that this finding and all associated components be reviewed, and corrected as needed, by a qualified, licensed contractor.

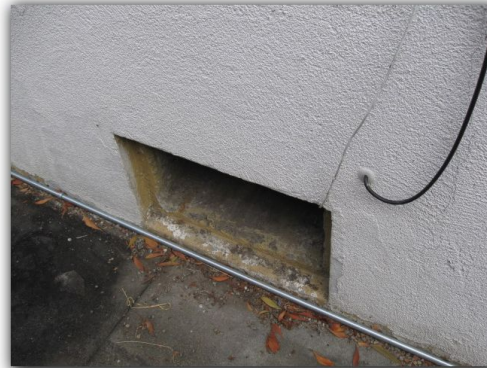
Opening at left rear corner of building has separated screen, possibly allowing pest intrusion, such as rodents, which can cause damage and increase health risk. Recommend that this finding and all associated components be reviewed, and corrected as needed, by an appropriate, qualified contractor.

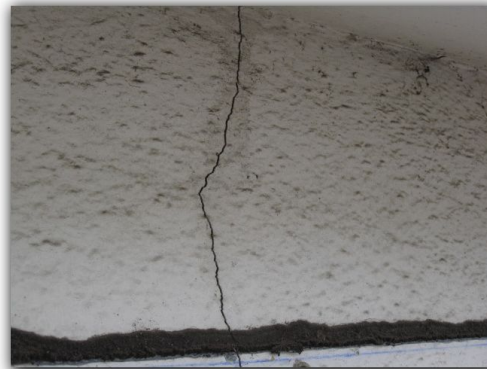
Stucco siding is cracked and holed at a number of locations, including right side of building near windows and under eave. Although stucco is relatively brittle and often cracks, gaps may allow excessive moisture onto water barrier behind stucco, which can increase the risk of moisture intrusion and deterioration of building materials within or promote microbial growth. Inspection within walls is beyond the scope of a home inspection. Recommend that this finding, all possibly associated components/areas, and remaining siding be reviewed, and patched/corrected as needed, by a qualified, state licensed plastering contractor.

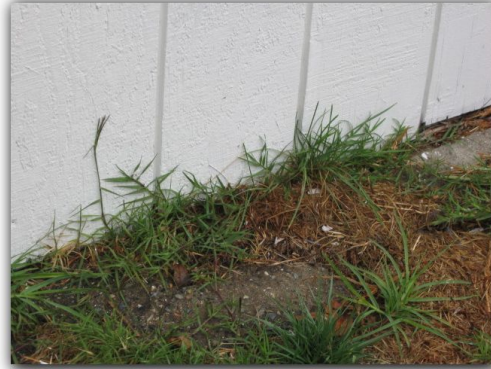
Wood siding at a number of locations is in contact with, or too close to, soil, which may expose siding to excessive moisture and cause deterioration. Recommend soil/siding separation and siding portions that were covered by soil be reviewed, and corrected if needed, by an appropriate qualified contractor.

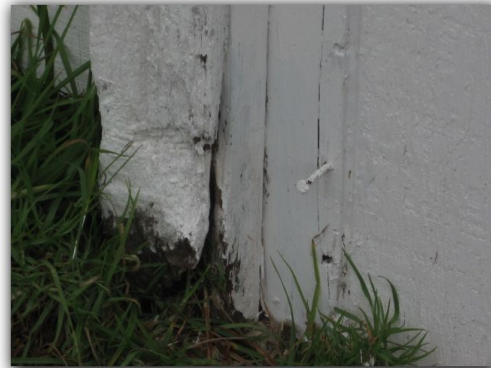
Wood siding on garage and adjacent building has deterioration/gaps at a number of locations, such as near front ground and above garage door. Increases risk of moisture intrusion, which may cause deterioration of building materials within or promote microbial growth. Inspection beyond the surface is beyond the scope of a home inspection. Recommend that this finding, all associated components, and remaining siding be reviewed, and corrected as needed, by an appropriate qualified licensed contractor. Recommend obtaining, or referring to, a structural pest ("termite") inspection report for further assessment and recommendations regarding this finding and other wood components on the property they inspect more extensively than a visual home inspection.

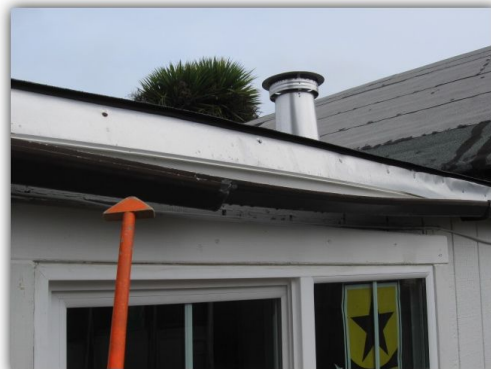
Gutter on front side of garage building is separating and sloped, allowing roof drainage to miss gutter and possibly restricting drainage, promoting clogging, and causing water ponding, which can increase risk of corrosion or gutter flooding, which can expose roof edge shingles, and wood sheathing to water damage or cause overflow to expose foundation and siding to excess moisture and deterioration. Recommend that this finding, all associated components, and remaining roof drainage system be reviewed, and corrected if needed, by a qualified gutter contractor and any other contractors needed. Roof drainage system should be inspected and maintained routinely.

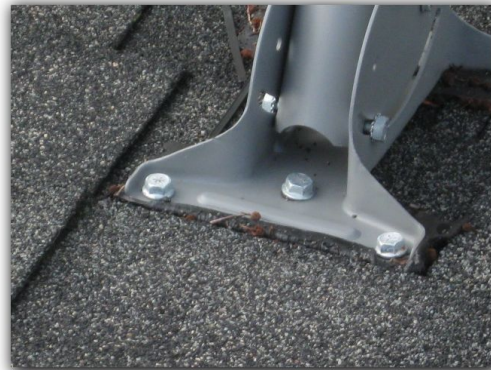
Satellite dish fasteners do not have sealant, which could allow moisture intrusion and damage building materials below and promote fungus. Recommended that this finding and remaining roof be reviewed, and corrected as needed, by a qualified, licensed roofing contractor.

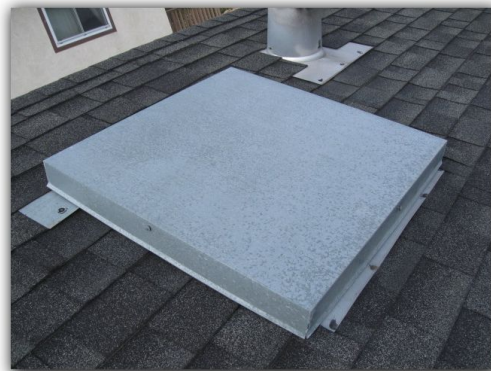
Metal has been installed on roof. Possible previous hatch noted in attic below. May increase risk of moisture intrusion. Recommend seller disclose any known history, including any evaluation/repair documentation or permits, in order to assist buyer in determining current condition and confirm proper repairs, which may require review by an appropriate, qualified, state licensed contractor/specialist.

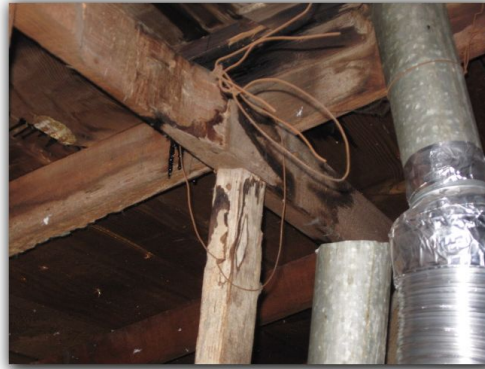
Roof framing in attic has staining consistent with water exposure. Possible past, or present, leak. May, or may not, be significant. Excessive moisture exposure has the potential to cause deterioration, microbial growth, and compromise the structural integrity of wood. Recommend that this finding and all associated components/areas be reviewed, and corrected if needed, by a qualified, state licensed roofing contractor.

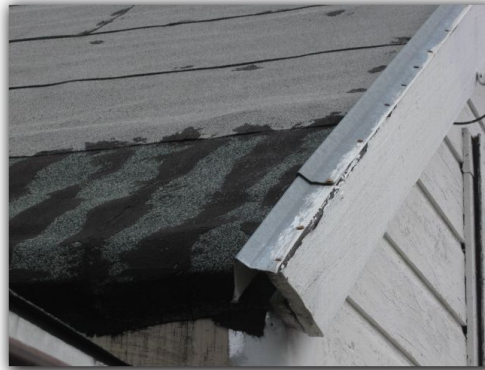
Roofs on detached garage and adjacent building have a number of material defects, such as improper flashing installation, exposed sheathing at front perimeter, improper perimeter roofing installation, and roof tiles noted laying on composition shingles at perimeter of left adjacent building. Roof portions may be at, or near, the end of their useful lives. Repairs noted, and evaluation of repairs is beyond the scope of a Home Inspection. Recommend that the garage and adjacent building roofs and all associated components/areas be reviewed, and corrected as needed, by a qualified, state licensed roofing contractor.

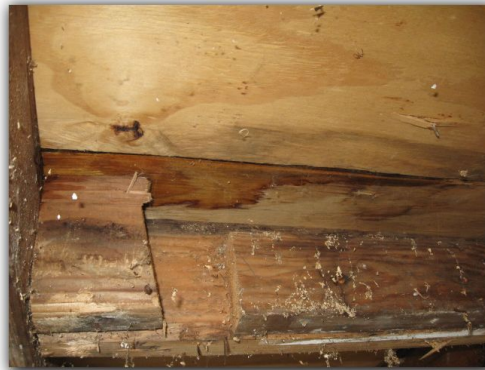
Wood roof sheathing in building adjacent to garage has water, indicating a leak. Recommend that this finding, all associated components/areas, and remaining roof and roof framing be reviewed, and corrected as needed, by a qualified, state licensed roofing contractor.

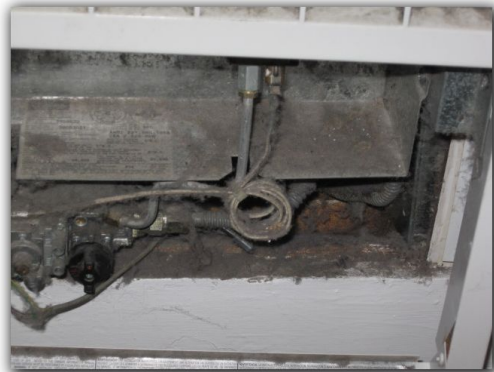
Wall furnace has debris near air intake and burner. Debris can mix with air for burner and possibly cause incomplete combustion of the gas fuel, which may compromise safety. Servicing may not have been performed sufficiently recently. Recommend that the furnace be cleaned, serviced, portions of the heat exchanger that are not readily visible inspected, and corrections performed as needed, by a qualified, state licensed HVAC contractor.

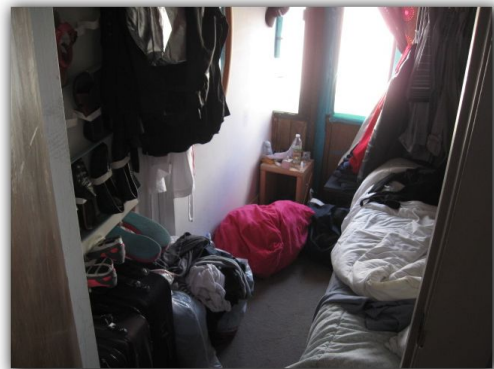
The rear room additions do not have a permanent source of heat as required. Recommended that this finding be reviewed and corrected by a qualified licensed HVAC contractor.

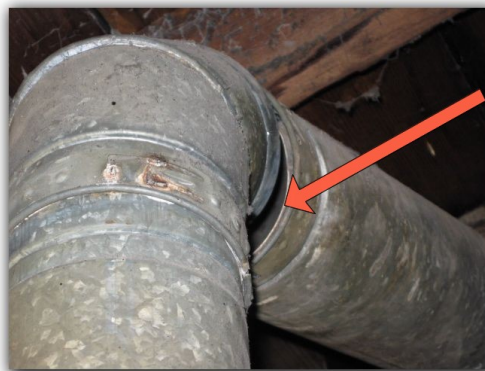
Water heater's burner exhaust vent pipe is separated in attic, possibly allowing burner exhaust gases to escape. Burner exhaust gases contain carbon monoxide, which is odorless, colorless, and can be fatal in sufficient amounts. Recommend notifying the Listing Agent to have the condition corrected by a qualified, state licensed plumbing contractor as soon as possible. Recommend reviewing the carbon monoxide information at the following Consumer Product Safety Commission website: www.cpsc.gov/cpscpub/pubs/466.html.

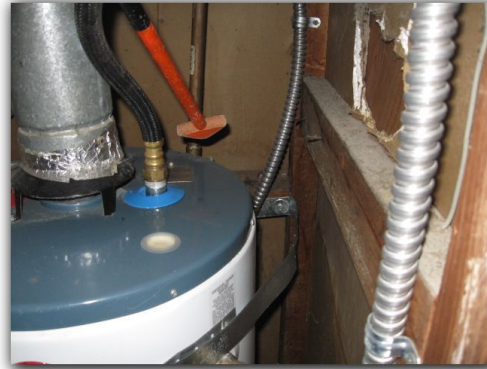
Water heater seismic restraint straps are not securing water heater against wall or wood/metal blocking between water heater and wall. An earthquake can move an insufficiently secured water heater and possibly cause a gas leak that may cause a fire or explosion; or cause a water leak and water damage; or cause a burner exhaust leak that may expose residents to carbon monoxide, which is odorless, colorless, and can be fatal in sufficient amounts. Recommend that this finding and remaining water heater be reviewed, and corrected as needed, by a qualified, state licensed plumbing contractor.

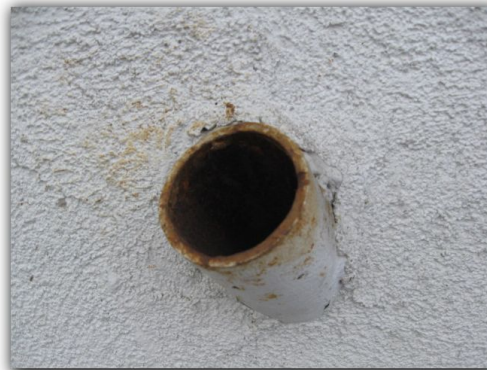
Possible drain "clean-out" (pipe for plumber tool access) at right side of building does not have a cap, possibly allowing drainage or drainage gases to escape. Recommend that this finding and all associated components be reviewed, and corrected as needed, by a qualified, state licensed plumbing contractor.

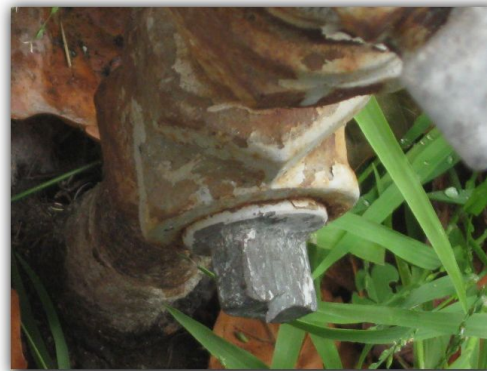
Main gas valve at right front corner of building is not completely at the "on" position. Recommend that this finding and all associated components/areas be reviewed, and corrected as needed, by a qualified, state licensed plumbing contractor.

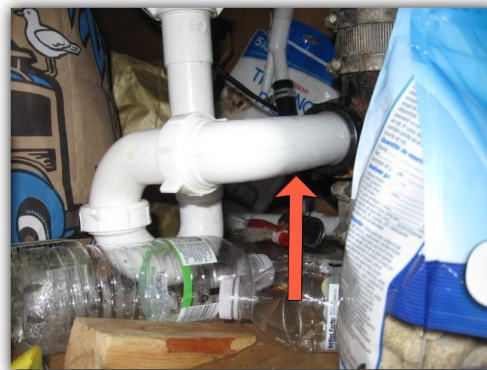
Drain pipe under kitchen sink has horizontal pipe ("trap arm") sloping up, possibly restricting drainage and promoting clogging. Recommend that this finding and all associated components be reviewed, and corrected as needed, by a qualified licensed plumbing contractor.

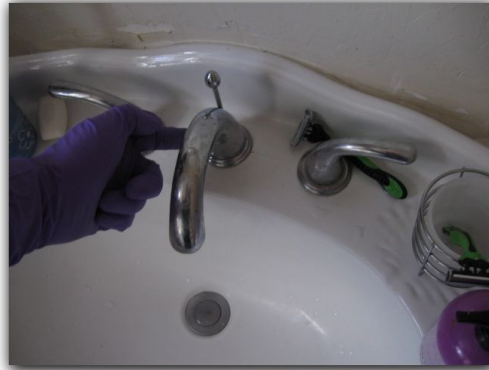
Spout for faucet on rear bathroom sink is loose, possibly indicating damage or allowing further damage. Recommend that this finding and all associated components be reviewed, and corrected as needed, by a qualified licensed plumbing contractor.

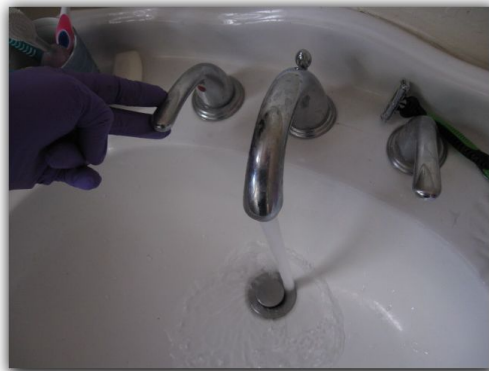
Handles for sink faucet in rear bathroom are difficult to operate. Recommend that this finding and all associated components be reviewed, and corrected as needed, by a qualified, state licensed plumbing contractor.

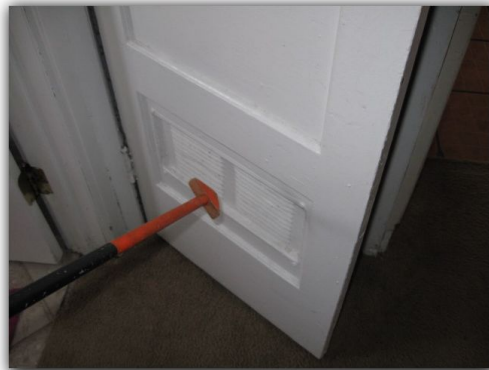
Water heater closet has a vented door, creating a carbon monoxide hazard and does not meet modern safety practices. Carbon monoxide in the burner exhaust may enter the house interior under certain circumstances, such as during startup, backdraft, or burner exhaust vent leak. Carbon monoxide is odorless, colorless, and can be fatal in sufficient amounts. Water heater would be safer in a dedicated water heater closet with listed (approved) self-closing, weather-stripped door, and air communication solely with the exterior air, or a direct vent water heater can be installed. Recommend that this finding and all associated components be reviewed, and corrected as needed, by a qualified, state licensed General contractor. Recommend installing carbon monoxide alarms wherever recommended by the alarm manufacturer. Recommend reviewing the carbon monoxide information at the following Consumer Product Safety Commission website: www.cpsc.gov/cpsc/pub/pubs/466.html.

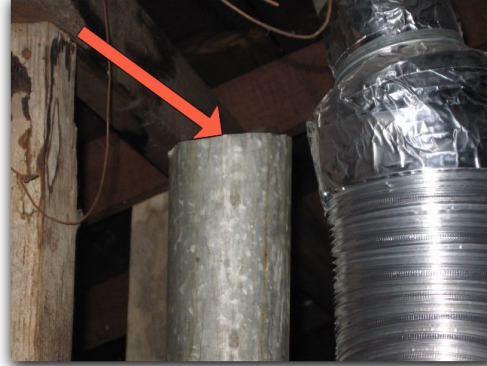
Pipe cut and terminates in attic. Pipe should be traced to determine current, or past, purpose and capped if needed by a qualified, state licensed plumbing contractor or other appropriate contractor.

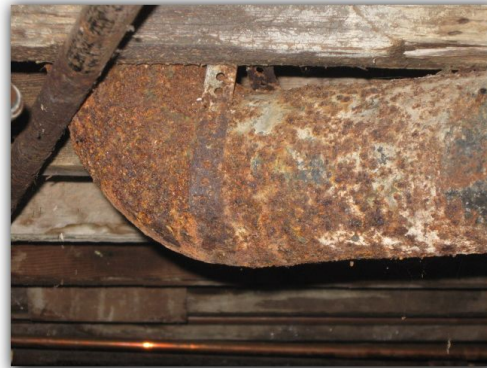
Iron drain pipe in crawl space for toilet has corrosion, which can be insignificant surface corrosion, have limited life expectancy, or be in need of replacement. Although insignificant surface corrosion is common, some corrosion may be at risk of causing leaks when iron pipes are this old. If the more comprehensive evaluation that can be provided by a plumbing contractor is desired, contact a qualified, state licensed plumbing contractor.

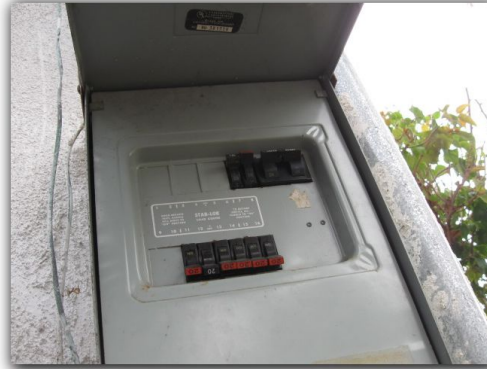
Circuit breaker labeling for main panel is incomplete. Labeling which appliance/circuit each breaker controls allows shut-off of the intended circuit, which can avoid shock/electrocution when working on wires that are assumed to be shut off. Recommend that this finding and all associated components be reviewed, and corrected as needed, by a qualified, state licensed electrical contractor.

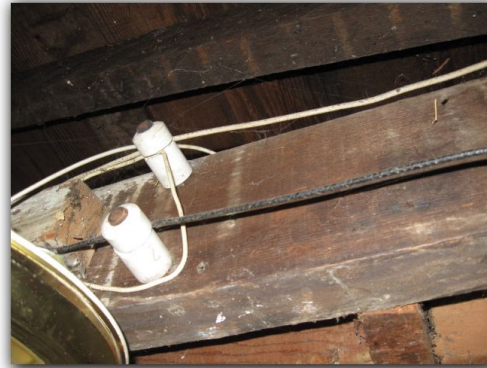
Knob & Tube electrical wiring noted in primary building and garage, some, or all of which, is in use. Knob & Tube wiring is an obsolete design; is an aged system that may have wire or insulation deterioration; and does not have grounding wires, all of which increase the risk of shock/electrocution or fire. Also, Knob & Tube wiring does not have the capacity to carry certain modern electrical current loads; creates an increase risk of fire when covered with thermal insulation; and is not acceptable to some homeowners insurance companies. Recommend that the entire electrical system be reviewed for the presence and condition of Knob & Tube wiring and any Knob & Tube wiring be replaced with modern wiring by a qualified, state licensed electrical contractor.

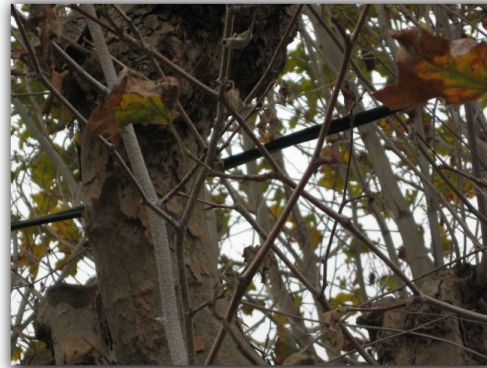
Electrical overhead service wires ("service drop") at left front corner of building are contacting tree branch(s), which can possibly damage wire insulation, wires, connections, or mast on roof due to tree branch contact or pressure. Recommend having the tree pruned by a qualified tree pruning contractor, and, if necessary, having the utility company temporarily remove and replace the wires.

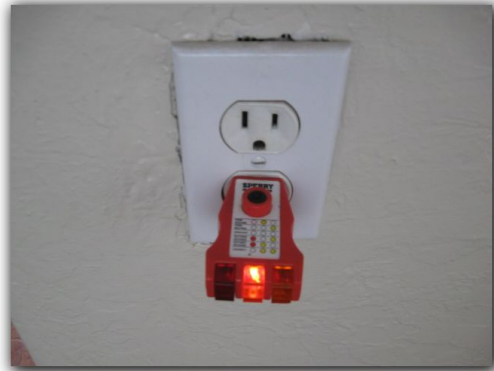
Three-prong electrical receptacles at a number of locations, such as living room, are not grounded. Other receptacles not tested during representative sampling may also be not grounded. Recommend having the 3-prong receptacles grounded by a qualified, state licensed electrical contractor to add safety from ground fault shock, allow proper operation of some devices, and meet current conventional construction safety practices.

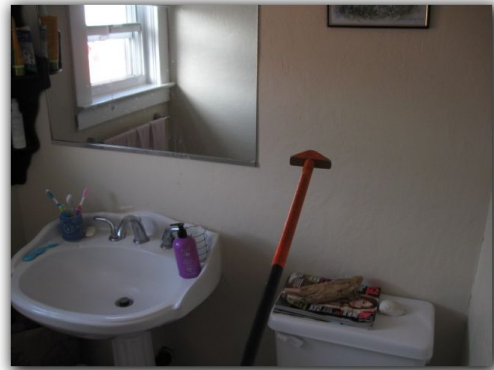
Receptacle outlet not installed in rear bathroom. If installation is desired, recommend installation of a GFCI receptacle by a qualified, state licensed electrical contractor.

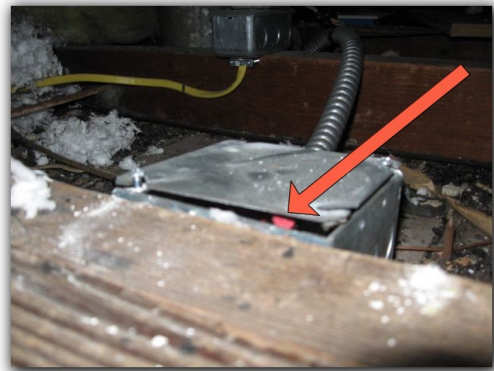
Junction box in attic near attic access hatch has cover plate gapped, exposing current-carrying components and creating a risk of shock, electrocution, or spreading any junction box fire. Recommend that this finding and all associated components be reviewed and corrected as needed by a qualified licensed electrical contractor.

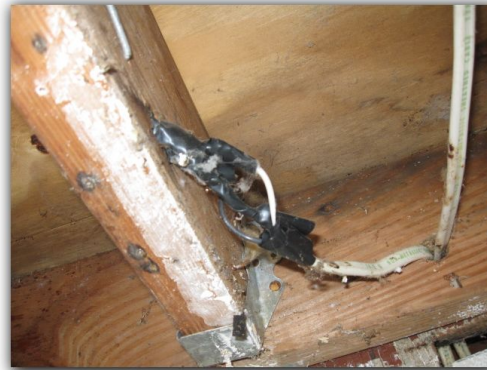
Wire connections at a number of locations in garage, such as at ceilings, are not within junction boxes. Increases risk of loose connections, which may cause overheating, arcing, or fire. May also cause disconnection, which increases risk of shock/electrocution. Recommend that this finding and all associated components be reviewed, and corrected as needed, by a qualified state licensed electrical contractor.

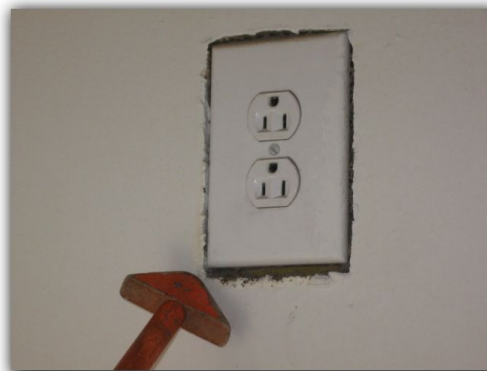
Electrical receptacle outlets in garage and adjacent building are not the type with GFCI shock protection. GFCI receptacles have a button that pops out and shuts off electricity at the receptacle before shock/electrocution from an appliance ground fault, which would be more severe if the person was in contact with water/liquid. Although GFCI receptacles may not have been required at these locations at the time of construction, recommend upgrading by having GFCI receptacle(s) installed by a qualified licensed electrical contractor to reduce the risk of ground fault shock/electrocution and meet current conventional construction safety practices. Ideally, GFCI receptacles should be installed in bathrooms, kitchen, at laundry/bar sinks, garage, exterior, and any area near water.

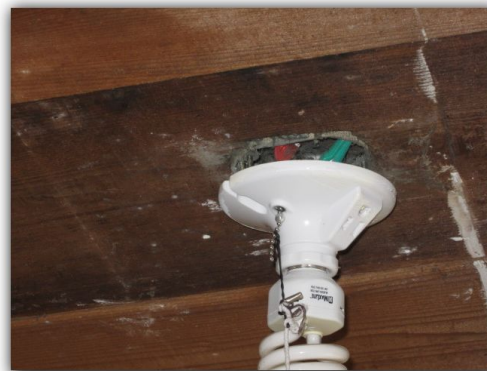
Light fixtures at a number of locations in garage and adjacent building are not properly secured, and some are hanging by electrical wiring, increasing risk of wire damage or poor connection, which can cause overheating, arcing, or fire. Recommend that this finding and all associated components be reviewed, and corrected as needed, by a qualified, state licensed electrical contractor.

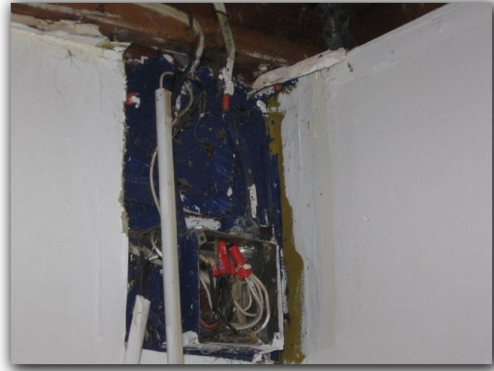
Junction box at left rear corner of building adjacent to garage has cover plate missing, exposing current-carrying components and creating a risk of shock, electrocution, or spreading any junction box fire. Recommend that this finding and all associated components be reviewed and corrected as needed by a qualified licensed electrical contractor.

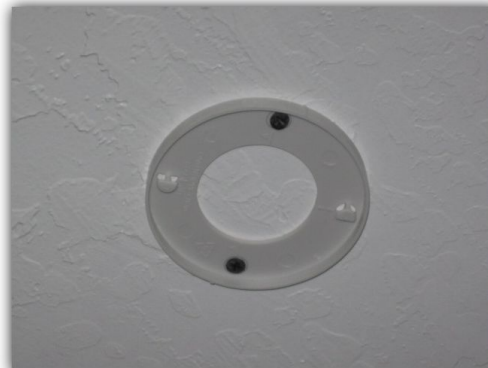
Smoke alarms not installed in all bedrooms. Recommend upgrade installation as appropriate to meet current safety practices, which recommends installation at least in bedrooms, bedroom hall, garage, and each level (if present). Installing smoke alarms in additional rooms/areas can be expected to increase safety. Recommend replacement of all smoke alarms that could be older than 10 years, which is when smoke detection parts are less likely to function. Pressing the "test" button only confirms that the smoke alarm's alarm sound generation works but does not test the smoke detection mechanism, which may not be working even though the alarm sounds while pressing the "test" button.

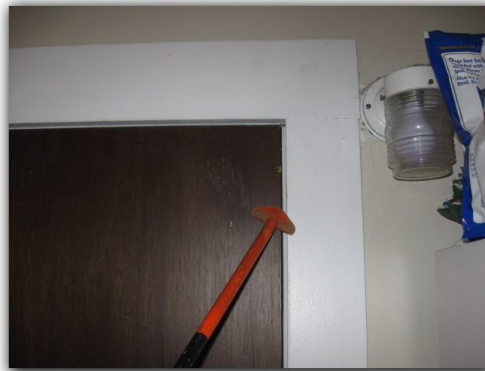
Door to right rear room addition drags door jamb. Various possible causes, such as excessive paint, misalignment, loose hinge, or building movement. Other doors not tested during sampling may also be faulty. Recommend that this finding, all associated components, and remaining doors be reviewed, and corrected as needed, by an appropriate, qualified contractor.

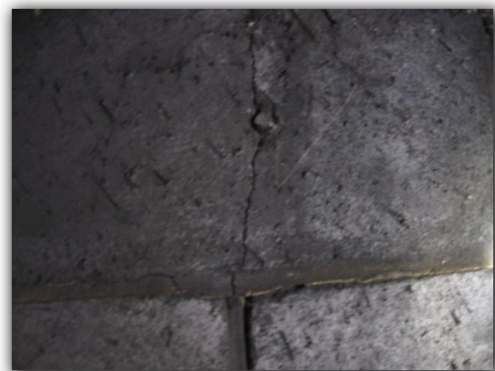
Firebrick/mortar gapped/cracked at rear wall of fireplace. May increase risk of fire/heat escape, which could damage materials behind or cause a fire. Sufficient deterioration may compromise structural integrity. Recommend that the NFPA Level 2 inspection be performed by a qualified chimney specialist.

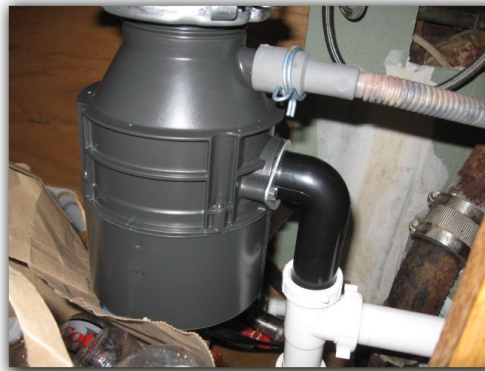
Disposal noisy. Could indicate debris or damage. Recommend that this finding and all associated components be reviewed, and corrected as needed, by a qualified licensed plumbing contractor.

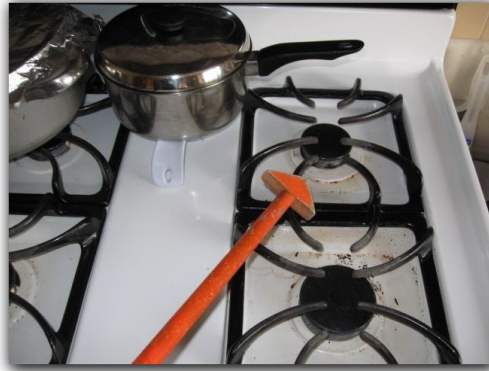
Range burner at right rear does not readily ignite. Recommend contacting the utility company or a qualified appliance contractor for servicing. Recommend correction before using range to avoid the risk of fire or burn injury due to unignited gas accumulating in room/house until it is ignited by another burner or other ignition source.

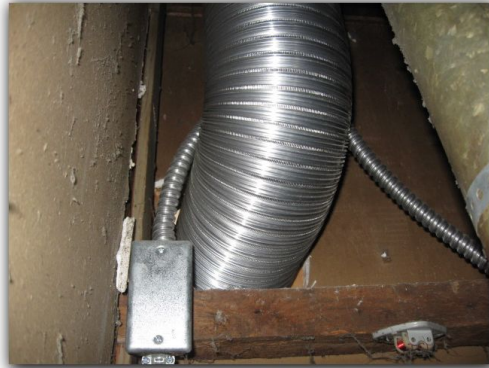
Range exhaust vent at top inside water heater closet and attic is ribbed/corrugated, which can collect grease, which can spread any fire on stove, reduce ventilation efficiency, and contribute to grease deposits on fan/filter. Recommend replacement with smooth metal vent by an appropriate qualified contractor.
