Home Inspection Report

555 Angus Ave., San Bruno, CA

Inspection Date:
Thursday, October 25, 2012

Report Number:
20121025-01

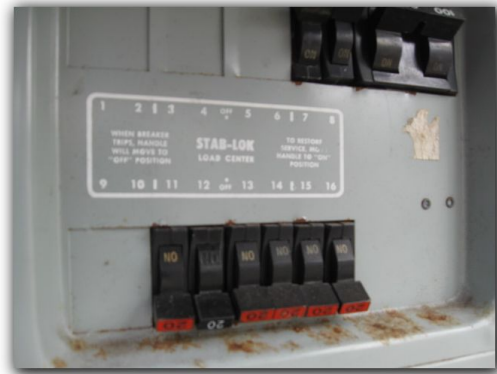
Main electrical panel at left front corner of building is a Federal Pacific brand, which is of questionable design and operating reliability, creating shock/electrocution and fire hazards. For example, circuit breakers may not trip off during overcurrent conditions, or circuits can remain connected/energized when breaker has tripped off. These panels have other defects that can cause panel bus fires and arcing failures, and Federal Pacific fraudulently provided misinformation to the company that approves electrical equipment design. Also, the electrical system is aged, which increases risk of unreliable or unsafe conditions that should be reviewed for maintenance if maintenance has not routinely been performed by an electrician. Inner cover was not removed to inspect interior components because these circuit breakers sometimes fall out/off from this panel when inner cover is removed. Recommend that this panel be replaced; the aged electrical system be reviewed; proper connections be confirmed if solid aluminum wiring is present; and any needed corrections be performed, by a qualified, state licensed electrical contractor familiar with Federal Pacific panel issues. Federal Pacific hazard information is available at <http://www.inspectapedia.com/fpe/fpepanel.htm>

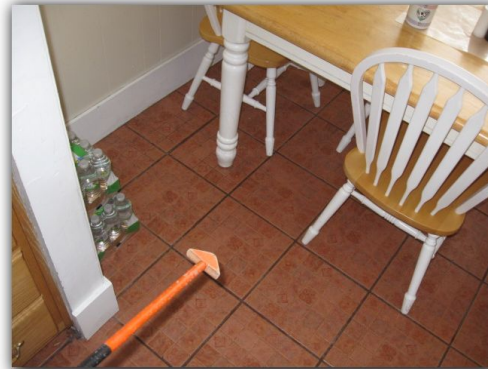
Floors at a number of locations appear to be sloped. Various possible causes, such as differential soil/building movement. Floor leveling may be advised. Recommend that this finding, all associated components, and remaining floors be reviewed, and corrected as needed, by an appropriate, qualified contractor/specialist, such as a qualified, licensed foundation contractor. Determining the cause or whether there is any structural or geotechnical (soil) significance/risks is beyond the scope of a home inspection and would require review by a structural engineer and geotechnical engineer.

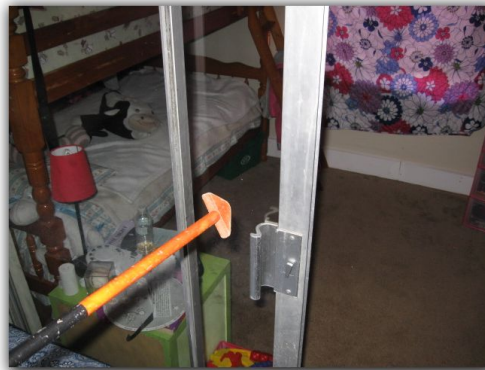
Sliding glass door to rear room addition could not be confirmed as being tempered safety glass. Although non-safety glass may have been common during this era of construction, non-safety glass in this location has become known to possibly cause serious injury when collisions from trip/slip/fall/bump contact breaks glass into extremely sharp shards. Caution advised. Consideration should be given to upgrading by having tempered safety glass installed by an appropriate qualified contractor to improve safety and meet current construction safety practices.

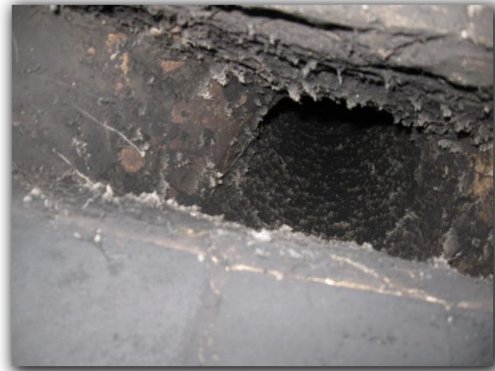
Soot apparent in firebox/chimney. Sufficient soot can increase the risk of a chimney fire and hide chimney defects. Recommend review, and cleaning if needed, by an appropriate licensed fireplace/chimney professional. Also, fireplaces/chimneys can have significant defects that may not become apparent during the limited scope of a home inspection. Some of these defects can possibly cause severe property damage, injury, or fire. The National Fire Protection Association (NFPA) recommends an NFPA 211 Standard, Level 2 fireplace and chimney inspection be performed by a qualified fireplace/chimney specialist at the time of property transfer. Recommend that the NFPA 211 Level 2 inspection be performed by a qualified chimney specialist before the removal of any investigation contingency and prior to the close of the transaction. The NFPA also recommends this type of inspection be performed on an annual basis and after an earthquake to help ensure safety.

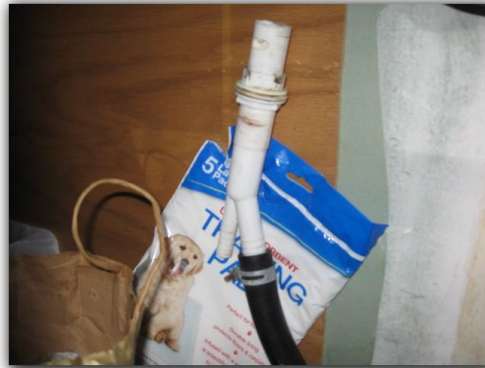
Dishwasher air gap (metal dome with slots for water drainage into sink) not installed on sink, but is under sink, where any drainage during a drain restriction would flood cabinet below sink. Air gap helps prevent drain clogs/restrictions from forcing drain contents back into dishwasher. Air gap is designed to divert drain contents into sink instead of dishwasher when drain is clogged/restricted. Recommend that this finding and all associated components/areas be reviewed, and corrected as needed, by a qualified, state licensed plumbing contractor.

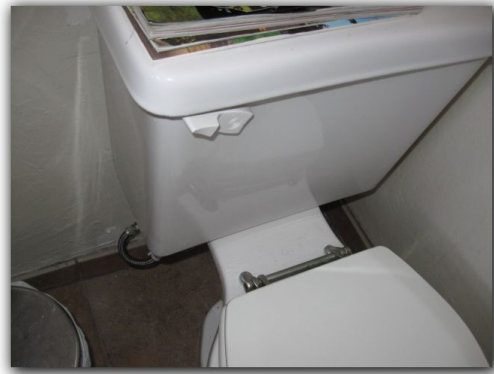
Toilet tank in rear bathroom does not have water, preventing flushing and testing. Various possible causes, such as water supply valve being turned off. Home inspectors do not turn valves because valve may have been turned off for a reason, such as to prevent leak or damage. Recommend seller disclose any known history to assist buyer in determining condition, which may require review by a qualified, state licensed plumbing contractor.

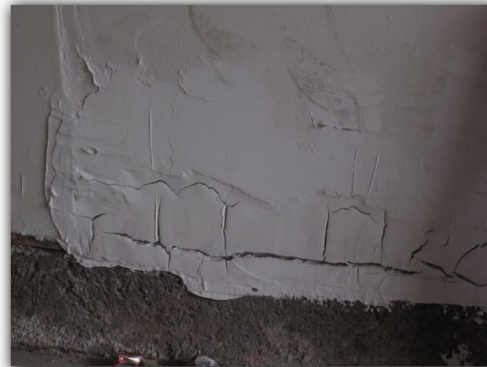
Wall on right side of garage has apparent repair near bottom of wall that is cracking. Determining the reason, conditions within wall, or adequacy of contractor/specialist work is beyond the scope of a home inspection. Moisture intrusion/damage or microbial growth may be present behind wall surface. Inspection beyond the surface is beyond the scope of a home inspection. Recommend that this finding and all associated components/areas be reviewed, and corrected as needed, by a qualified, state licensed General contractor or other appropriate, qualified contractor.

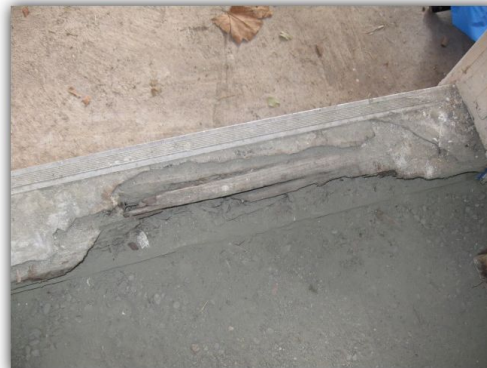
Garage interior has damage at a number of locations, such as threshold between building sections and flooring. Recommend that this finding and all associated components/areas be reviewed, and corrected as needed, by a qualified, state licensed General contractor or other appropriate, qualified contractor.

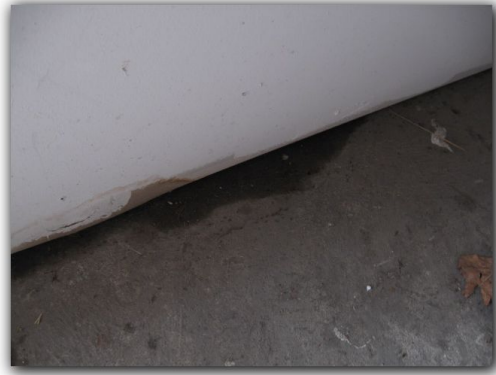
Front wall has apparent water intrusion at floor, which may cause deterioration of building materials within or promote microbial growth. Recommend that this finding and all associated components/areas be reviewed, and corrected as needed, by a qualified, state licensed General contractor or other appropriate, qualified contractor.

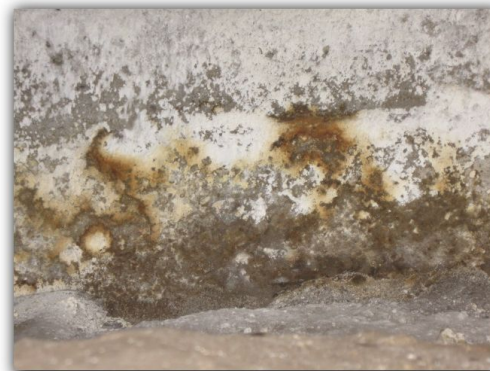
Foundation perimeter stem wall in crawl space across from right rear access hatch has "efflorescence" (white area of mineral leaching from concrete due to moisture exposure) and possible deterioration. Moisture in exterior soil or from surface drainage will often seep through concrete and leave minerals from concrete on the surface. In some cases, deterioration can be caused by insufficient exterior drainage combining with sufficient moisture exposure over a long period of time. Although certain amounts of efflorescence may not be significant, further review would be necessary to determine whether any locations have significant deterioration. Also, staining consistent with foundation interior rebar corrosion noted.

Corroding rebar can expand and damage foundation. Exterior grade does not slope away from building. Recommend that the foundation be reviewed, and monitored on a regular basis, by a qualified, state licensed foundation contractor. Recommend reducing water exposure by improving drainage on grounds. Recommend using appropriate, qualified, licensed contractors.

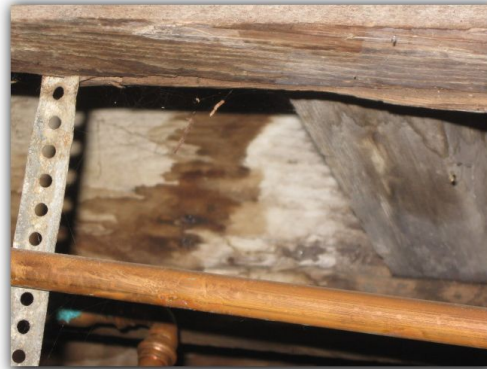
Sub-floor in crawl space near bathroom(s) has white stains consistent with fungus due to past, or present, moisture exposure/intrusion, which can cause wood damage. Recommend obtaining, or referring to, a structural pest inspection ("termite") report for assessment and recommendations regarding this finding and the other wood components on the property they inspect. Structural pest inspectors (formerly titled "Branch 3 Structural Pest Control Operators") are wood and wood boring insect specialists who are typically hired during a property transfer transaction to provide a more comprehensive wood evaluation, including probing the wood to determine the presence, or extent, of wood deterioration, moisture intrusion, fungus, wood boring insect infestation/susceptibility. As a specialist, they can also provide cost estimates and corrective work.

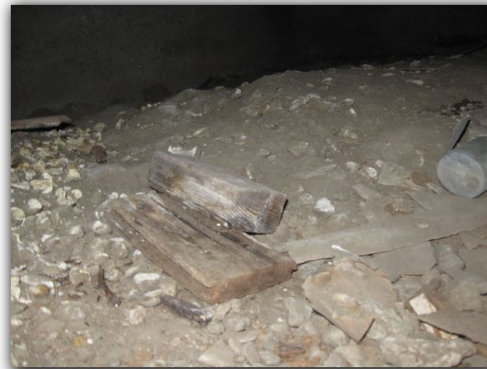
Wood ("cellulose") debris noted in crawl space at a number of locations. Wood can attract wood boring insects to building wood framing, which can cause damage and compromise the structural integrity. Recommend removal of any scrap wood in crawl space by a qualified person.
